# Manhole Inspection Summary

Manhole # S39C\_\_026MH

Insp Date: **3/23/09 1:02 PM**

**Location** Address: **1000 E LEXINGTON ST**

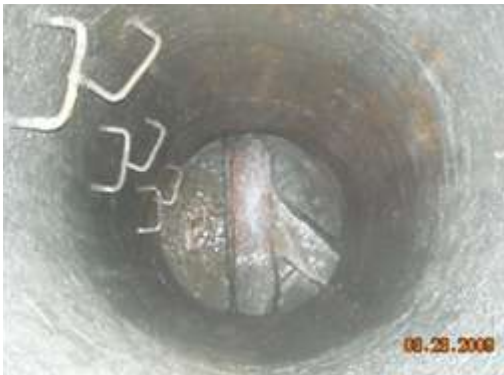
Defect 6

☒ **Wall**

WALL INFILTRATION IN CORBEL AND BARREL

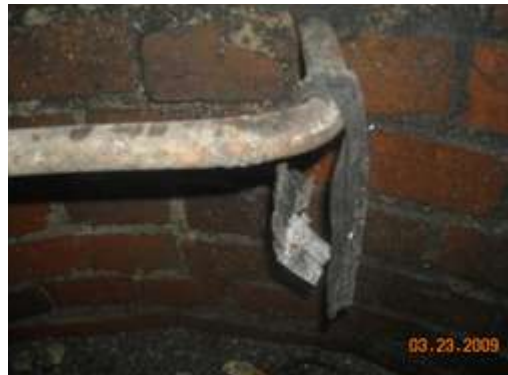
Defect 4

☒ **Evidence Of Surcharge**

Depth: **3**

EVIDENCE OF SURCHARGE

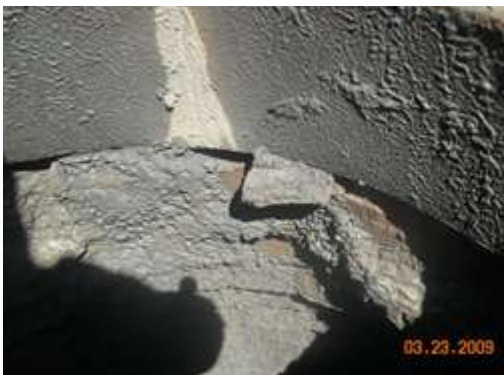
Defect 3

☒ **Loose Brick**

☒ **Deteriorated**

☒ **Joint**

DETERIORATING AND LOOSE BRICKS IN CHIMNEY, JOINT INFILTRATION

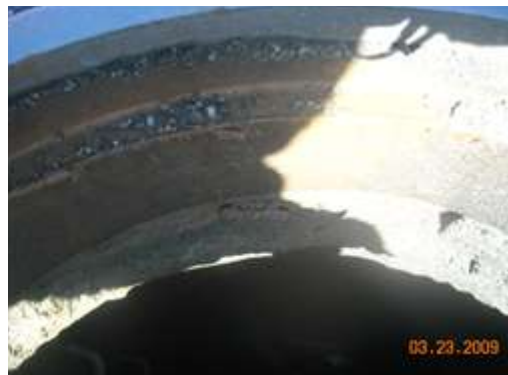
Defect 2

Offset: **1.5** (in.)

☒ **Leaks**

FRAME OFFSET

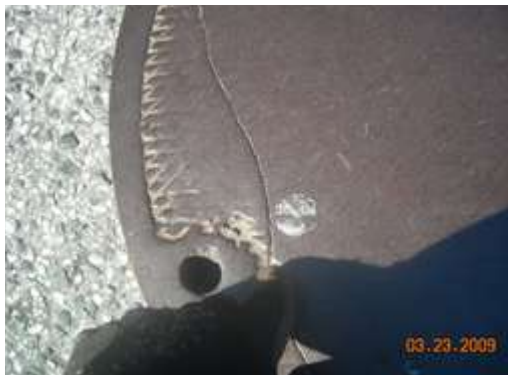
Defect 1

Condition: **Cracked**

CRACKED COVER

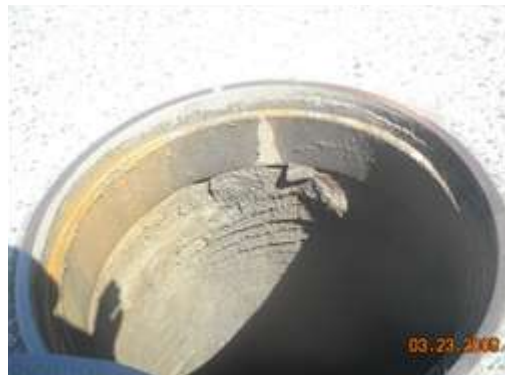
Defect 5

Subject To Ponding: **Sheeting**

INFLOW EVIDENCE FROM SHEETING

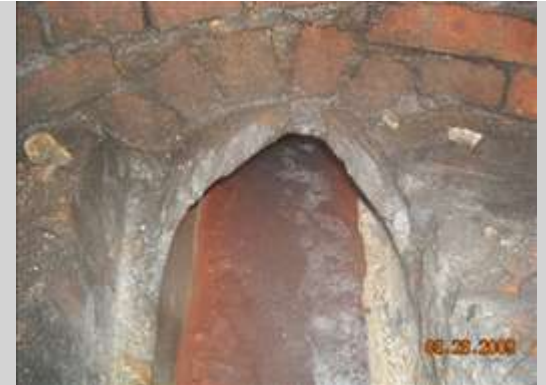
12 O'Clock Outflow

Pipe Height: **12** (in.) Rod and Bar (Angled)  
Pipe Material: **Clay** ☐ Pipe Lined  
Invert Depth: **13.20** (ft.) Flow Characteristics: **Fast**  
Deposits: ☐ None ☐ Mud ☐ Gravy ☐ Debris ☒ Grease  
Silt Depth: **2** (in.) Deposits Extent: **Light**  
Infiltration: **None** Pipe Seal Cond: **Sound**

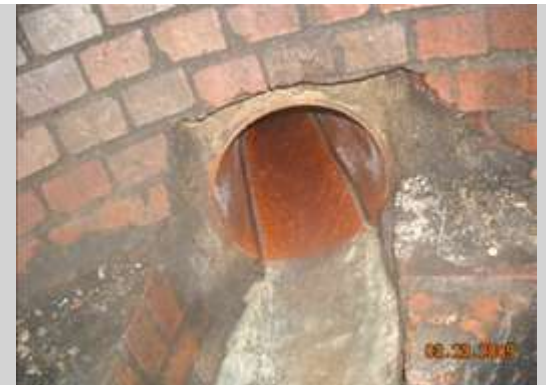
4 O'Clock Inflow

Pipe Height: **12** (in.) Rod and Bar (Angled)  
Pipe Material: **Clay** ☐ Pipe Lined  
Invert Depth: **12.70** (ft.) Flow Characteristics: **Fast**  
Deposits: ☒ None ☐ Mud ☐ Gravy ☐ Debris ☐ Grease  
Silt Depth: **0** (in.) Deposits Extent:  
Infiltration: **Evidence** Pipe Seal Cond: **Broken**

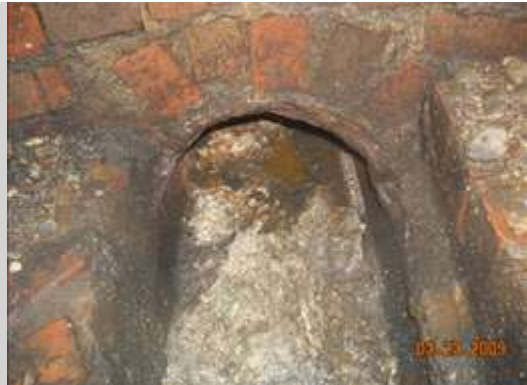
6 O'Clock Inflow

Deposits: ☐ None ☐ Mud ☒ **Sludge** ☐ Debris ☒ **Grease**

Silt Depth: **4** (in.) Deposits Extent: **Medium**
